Test Report

TORQUE TEST

$\frac{\text{CLIENT} - \text{BOOSKA}}{\text{PRODUCT} - \text{INFLATOR SOCKET}}$

AZT0237.23

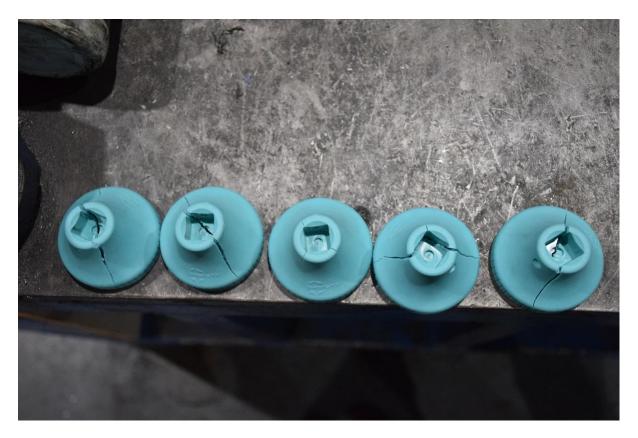
Figure 4: All Samples at Completion of Test

Test Specimen	Ultimate Torque	Damage to Test Specimen
#1	85 Nm / 62.69 ft lb	Diagonal crack emanating from the corners of the 1/2 inch drive socket
#2	86 Nm / 63.43 ft lb	Diagonal crack emanating from the corners of the 1/2 inch drive socket
#3	80 Nm / 59 ft lb	Diagonal crack emanating from the corners of the 1/2 inch drive socket, additional crack from another corner of the socket
#4	80 Nm / 59 ft lb	Diagonal crack emanating from the corners of the 1/2 inch drive socket, additional crack from another corner of the socket
#5	80 Nm / 59 ft lb	Diagonal crack emanating from the corners of the 1/2 inch drive socket
